TECHNICAL STUDY ON USING SILICONE PROTECTIVE COATING FOR CORROSION AND RUST PREVENTION

I. Kanouni
Managing Director and CEO
Midsun IKM
Vienna, Austria
imad@midsungroup.com

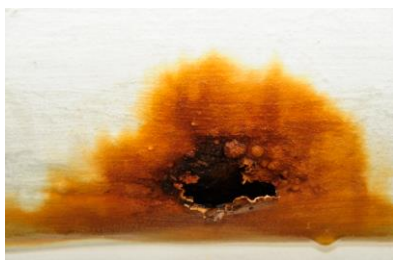
Acrylic/Urethane-based coatings are water based and are water permeable, which means water vapor can go both ways. When the water vapor pressure pushes into the coating system, the water molecule of oxygen in the water hits the steel and explodes. Thus, rust is the explosion on a molecular level when oxygen and water react with iron in the steel.

Fig. 1. Rust penetrated through an acrylic/urethane-based coating

Same goes with the oil and synthetic-based coating, rust formation was observed weeks after the application. These type of coating systems failed because of their property to trapped water vapor or letting in too much of it. They may be effective as rust prevention but not be a rust prevention for steel structures with existing rusts and corrosion.

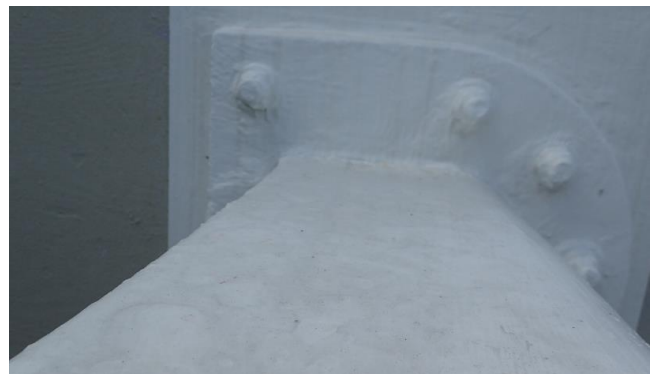
Fig. 2. Flanges after Silicone Protective Coating application

Solvent-free silicone protective coating is a top-notch resistance to weathering, water and chemical substances, making it ideal to use in coastal, industrial and desert areas. Silicone protective coating material safety data sheet (MSDS) was submitted to the Director of Mammals Exhibits to verify that there were no chemical or other substances present that are dangerous. Upon the approval, two-parts of silicone protective coating – water-based epoxy E5230 primer, were applied to the sanded and treated rim to fill-in any cracks or imperfections. Six to eight coats of silicone protective coating 100% solvent-free silicone white coating were applied and S2000 solvent-free seamseal fibered coatings were applied to flanges and bolts. Total curing period is only 3 days.

Six (6) months after the application, at 37°C and with a relative humidity for about 80%, no formation of rust and corrosion were observed.

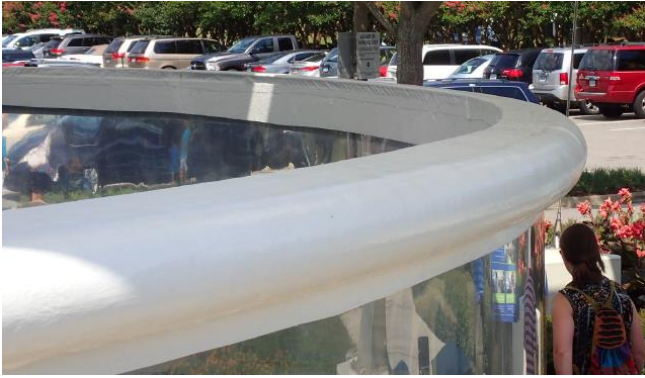
Virginia, USA – A seal tank rim, made of raw steel, which holds the clear acrylic sheet of water back is severely damaged. Observed scratches, grooves, imperfect welds and other imperfections have led the steel rim to rusting and corrosion. Several attempts of coating were done using acrylic, oil or synthetic based resin, but none were able to mitigate the rusting and corrosion.

Fig. 3. Seal tank rim after Silicone Protective Coating application
